Upper road to the breach

Upper-elevation road erosion and the descent into the breach area.

From the breach toward San Antonio Creek

Lower residential erosion corridor, Twisted Juniper Road, and the reported continuation to the creek.

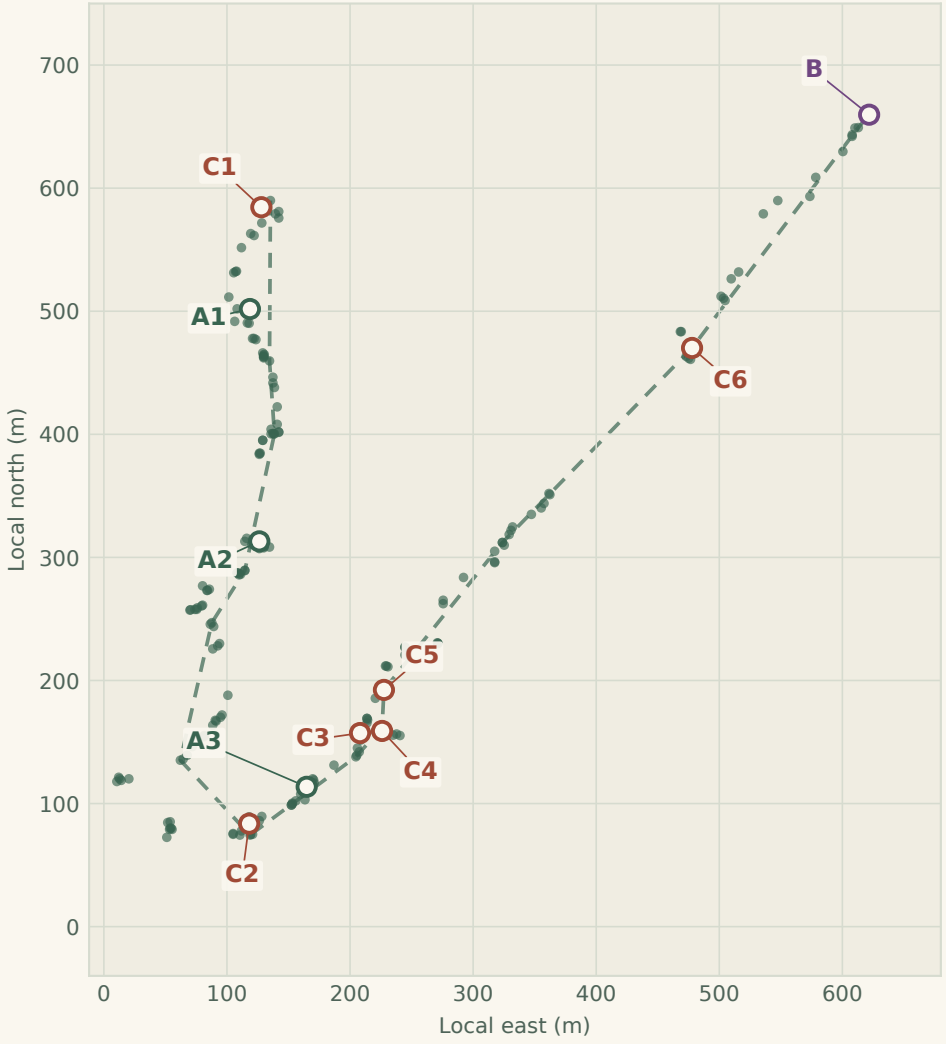
Upper elevation → Road erosion and culverts → Breach area (B) → Continue on page 2

Tina reports that the large bent culvert (C3) no longer carries water. The other upper culverts still convey flow. She links drops and outlet design with faster discharge.

B is the same approximate breach-area reference on both maps, based on lower-walk photos 012–014.

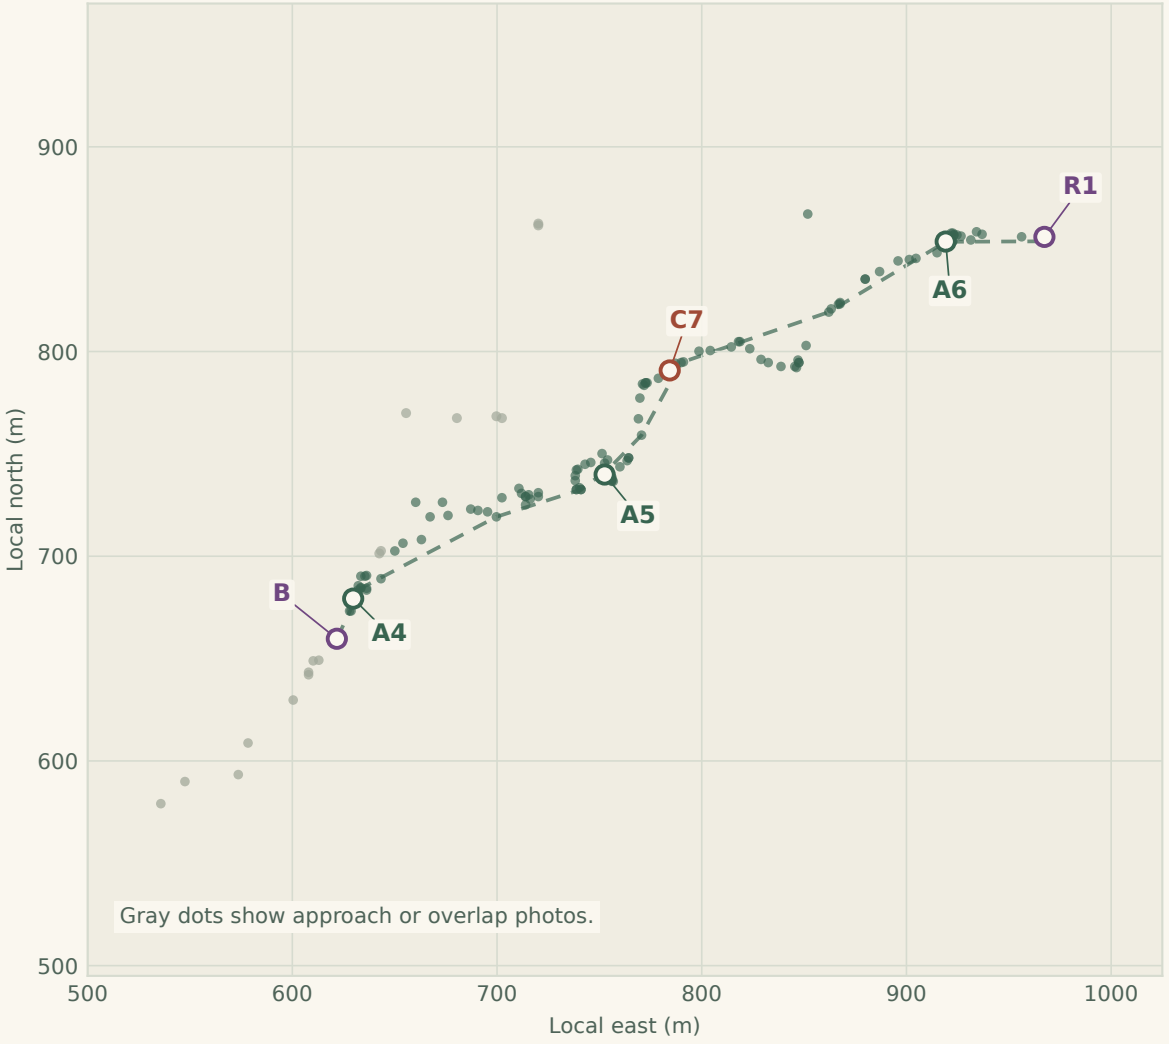
Breach area (B) → Residential erosion → Twisted Juniper washout (R1) → Toward San Antonio Creek

R1 is the recurrent washout at the old erosion path. There is no culvert at R1. Tina reports water crossing the road and eroding the left side toward the river.

Tina reports the lower culverts filled roughly halfway with sediment in one storm and stormwater went over the road. C7 is a separate photographed crossing.

Tina describes the route continuing along Twisted Juniper toward the creek. The exact point where this runoff enters San Antonio Creek still needs verification.
